April 1, 2024

URGENT SAFETY NOTICE, CAPTUS 4000E THYROID UPTAKE SYTEM

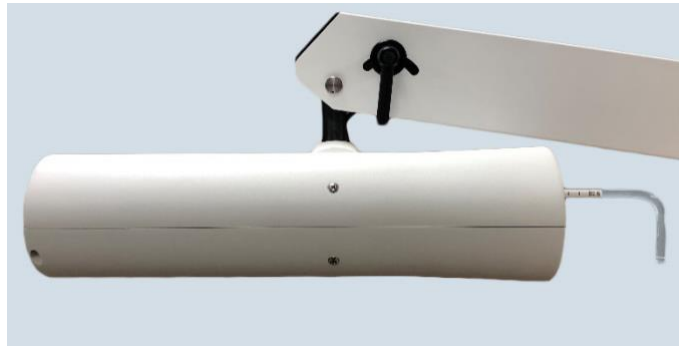
Figure 2: Collimator Positioning

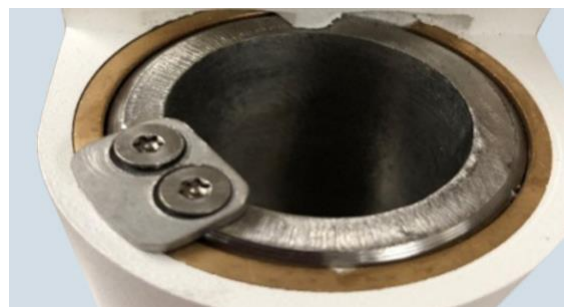
Figure 10: Example 2

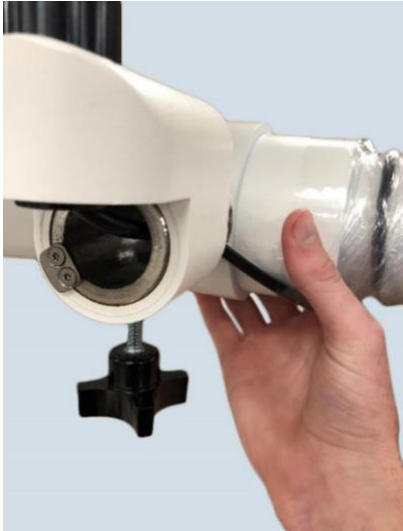
Figure 11: Hand Support Positioning

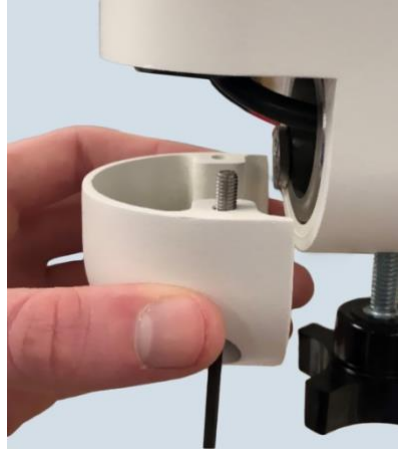
Figure 14: Housing Re-Assembly
